CAVITATION WEAR ON CENTRIFUGAL PUMP IMPELLENTS MADE FROM HASTELLOY C-276 ALLOY

Article in *Research on Engineering Structures and Materials* · May 2021

Tomás Fernández-Columbié*; **Jorge Luis Reyes-de la Cruz.**; **Isnel Rodríguez-González.**; **Ledennis Suárez-Torres.**

Universidad de Moa “Dr. Antonio Núñez Jiménez”. Ave. Calixto García #15, entre Ave. 7 de Diciembre y calle Reynaldo Laffita, Las Coloradas, Moa. Holguín. Mechanical Department. www.ismm.edu.cu

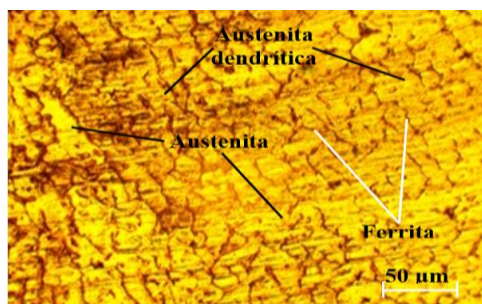
In order to determine the standard microstructure of the blades (Hastelloy C-276), a binocular optical microscope brand NOVEL model NIM-100 was used, equipped with a camera that allows obtaining photos of the microstructure. Figure 2 (samples under conditions of 27 and 34 % of leached liquor) shows a matrix structure with the ferrite in the grain edge and austenite, which is of the dendritic type, which is indicative of a previous treatment to obtain it. These characteristic phases are developed during the smelting process, because the dendrite appears as a result of temperature gradients and originates in the direction of such gradient.

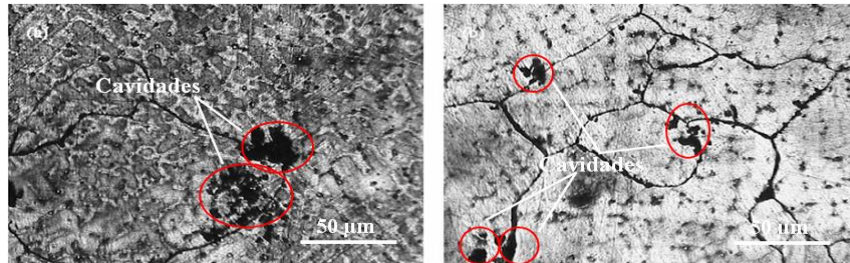
When the cavities is analyzing in the pump blades, it can be seen that, for a liquor concentration of 27 % (figures 4(a) and (b)), the cavitation phenomenon starts with small holes and cracks on the surface, leaving it susceptible due to the effect of the components present in the fluid. While, for a concentration of 34 % (Figures 5(a) and (b)), this defect increases with greater intensity, in the matrix the holes and cracks occur all along the grain boundaries. As the liquor concentrate increases, so do the cavities in the impeller blades, leading to deterioration of the crystalline structure of the alloy.

Figure 4(a) and (b). Blade surface cavities for 27 % concentration.

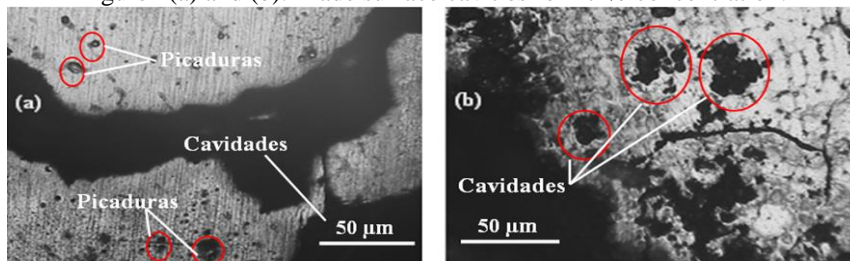
Figure 5(a) and (b). Blade surface cavities for 34% concentrations.

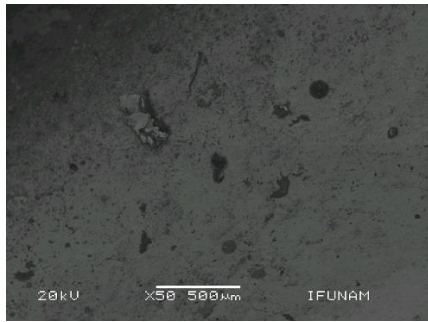
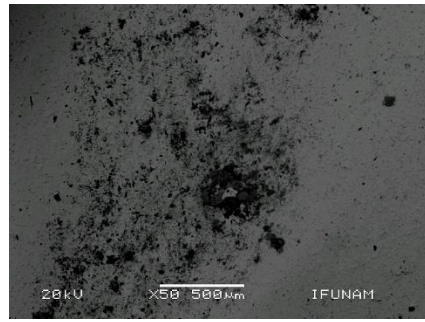
The behavior obtained, by means of SEM, figures 6(a) and (b), correspond to a 27% concentration on the surface of the Hastelloy C-276 super alloy, which shows a lower incidence of cavitation. Regardless of this condition, there is a damaged structure with the formation of pitting and the breaking of the passive layer, with the presence of carbides. The fluid has caused a widespread attack by the effect of intercrystalline corrosion, with the presence of cracks along the grain boundary. There is a line of grains that show crumbling, which weakens the passive layer and the mechanical resistance of the material.

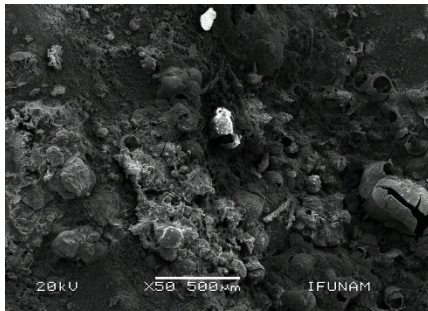
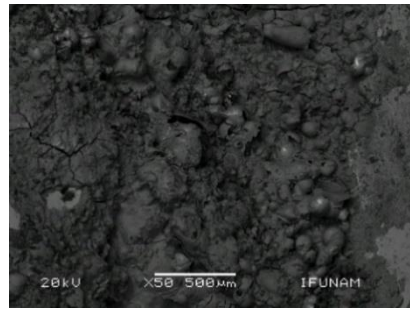
For 34 % concentration in the fluid (figures 6(c) and (d)), the material shows a more deteriorated surface with the presence of pores, cracks and carbides, there is a deformation of the dendritic phase and a non-textured matrix. The formation of the dark shade present on the surface, can be associated with the incrustations of the liquor in the grain boundaries, which leaves it susceptible to superalloy, giving rise to the phenomenon of cavitation.

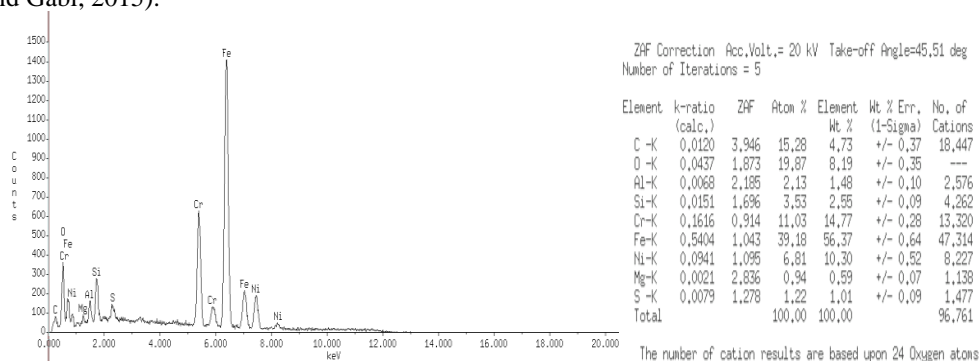
The SEM standards obtained in the different samples (Figure 7(a)), correspond to 27% of concentration and 7(b) to 34 %. An angle of 45.51° was used to obtain the diffractograms. It is observed that, there is a variation in the chemical elements, as the fluid interacts with the surface of the Hastelloy C-276 superalloy, the components of this hydro mixture leave the material susceptible to the phenomenon of cavitation, the bubbles influence the durability of the impeller. The presence of oxidizing or reducing substances, traces of CO₂ and organic substances in the solution can change this character and make the steels active or passive. There is a surface hardening as a result of the successive impacts of the shock waves that produce the appearance and implosion of the vapor bubbles generated by the cavitation process, which favors localized transformation with low levels of effort (Mittag and Gabi, 2015).

Figure 7(a). SEM for 27 % solids concentration in the fluid.

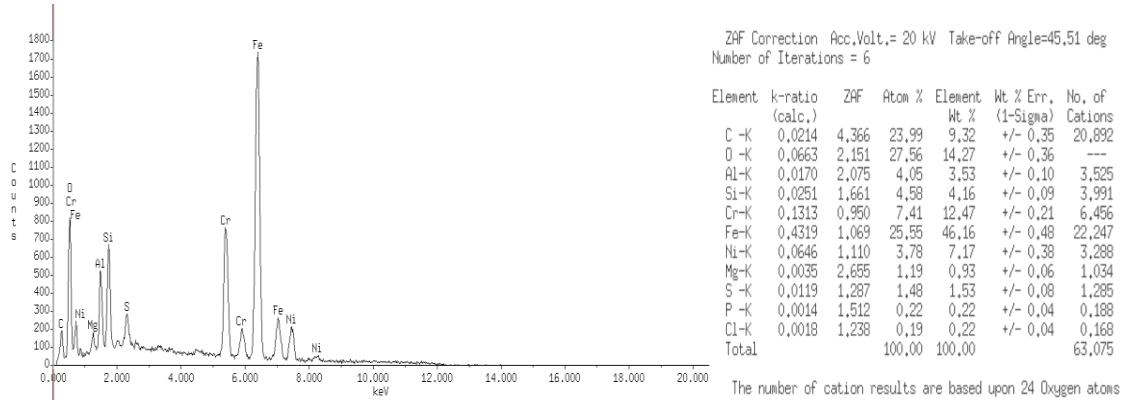
Figure 7(b). SEM for 34 % solids concentration in the fluid.

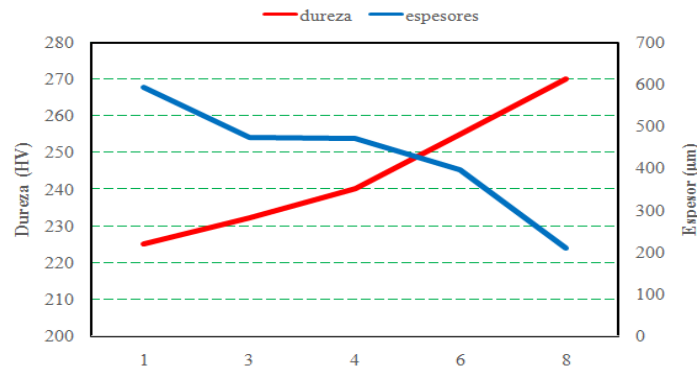
When evaluating the hardness behavior in relation to the thickness in one of the worn-out blades removed from service (figure 8), it can be seen that, for an initial value of 217 HV, in the Hastelloy C-276 superalloy, it increased to 225 HV at the upper end of said blade, a matter that is little affected by the effect of the implosion of the bubbles, however, as it approaches the lower end, this property increases until it reaches HV 270.

Figure 8. Hardness vs. thickness behavior.

There is an inverse relationship between hardness and thickness, the latter being reduced by the effect of fluid friction on the surface and causing a decrease in grain size due to the effect of pungeny.
