CAVITATION WEAR ON CENTRIFUGAL PUMP IMPELLENTS MADE FROM HASTELLOY C-276 ALLOY

Article in *Research on Engineering Structures and Materials* · May 2021

Tomás Fernández-Columbié*; **Jorge Luis Reyes-de la Cruz.**; **Isnel Rodríguez-González.**; **Ledennis Suárez-Torres.**

Universidad de Moa “Dr. Antonio Núñez Jiménez”. Ave. Calixto García #15, entre Ave. 7 de Diciembre y calle Reynaldo Laffita, Las Coloradas, Moa. Holguín. Mechanical Department. www.ismm.edu.cu

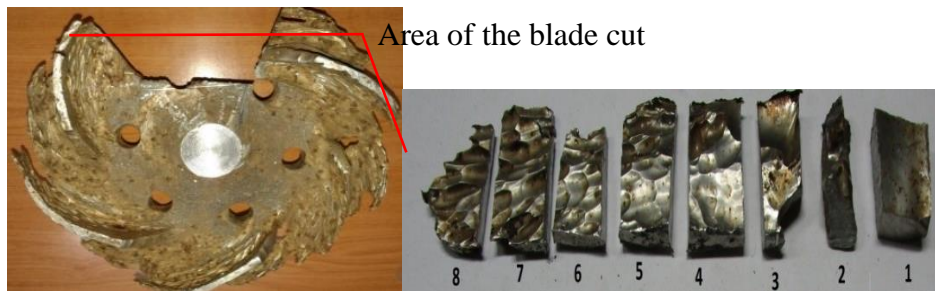
The cutting operation was carried out in a vertical milling machine, taking into account that the samples used were excessively large, as shown in figure 1, it was necessary to reduce them to a size that allowed its handling (15 x 15 x 32 mm), (ASTM E 92 Standard). This cut was made in such a way that an analysis could be made in all the areas affected by the fluid and then, from these areas, the mechanical metallurgical variations that arise in them could be established. After polishing, the samples were chemically attacked with 10 % mixture of nitric and hydrochloric acids.

Figure 1. Cut made to a blade of selected samples.

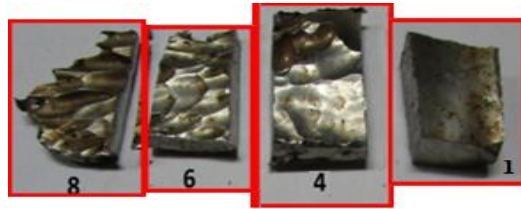
To determine the hardness, 4 blades were finned, as shown in figure 3. These areas were considered, taking into account the incidence of the fluid on them. Of the 8 samples cut, No. 1; 4; 6, were 8 also selected for hardness scanning. These were chosen because, when the bubbles implode, the effect on the blades is not homogeneous.

Figure 3. Hardness measurement in the different selected areas
